Manhole Inspection Summary

Manhole # S07GG1001MH

Insp Date: **5/28/09 10:16 AM**

Location Address: **REAR 3702 FERNHILL AVE**

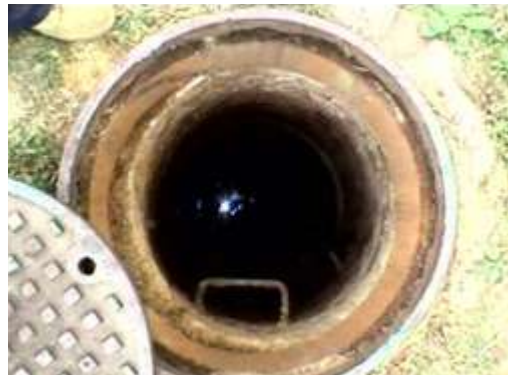
Defect 3

Frame Offset: **2** (in.) Condition: ☒ Sound ☐ Cracked ☐ Leaks

frame offset

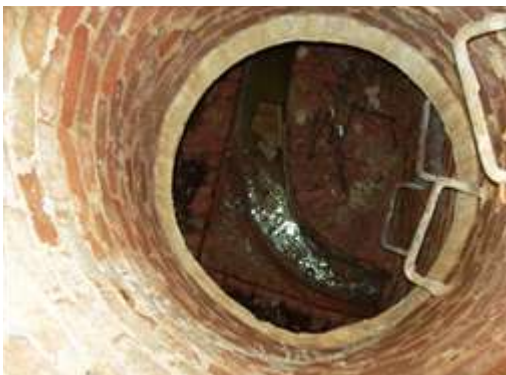
Defect 2

Surcharge ☒ **Evidence Of Surcharge** Depth: **1** (ft.) ☐ Active Surcharge Present

evidence surcharge

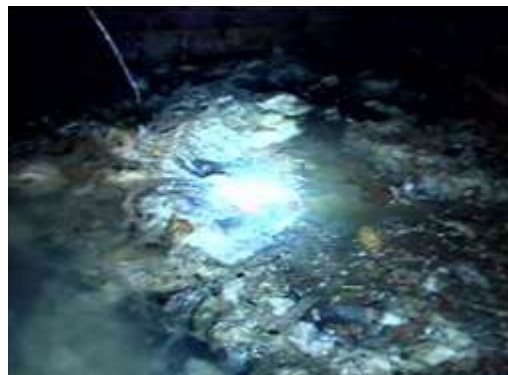
Defect 1

Condition: ☐ Sound ☐ Cracked ☐ Root Intrusion ☐ Deteriorated ☐ Leaks ☒ **Debris**

BENCH- DEBRIS

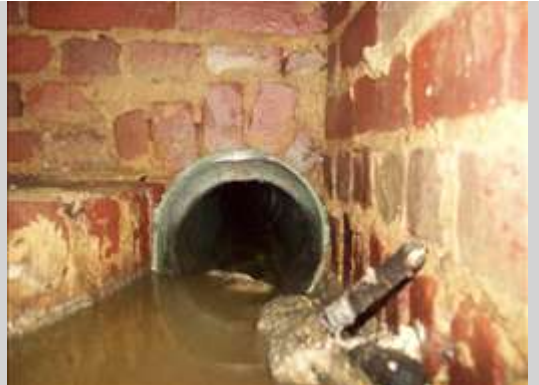
12 O'Clock Outflow

8 in. Circular Gravity Sewer
Pipe Out @ 12 O'Clock

Pipe Height: (in.) Direct
Pipe Material: **Clay** ☐ Pipe Lined
Invert Depth: **9.30** (ft.) Flow Characteristics: **Slow**
Deposits: ☐ None ☐ Mud ☒ Sludge ☒ Debris ☒ Grease
Silt Depth: **7** (in.) Deposits Extent: **Heavy**
Infiltration: **None** Pipe Seal Cond: **Sound**

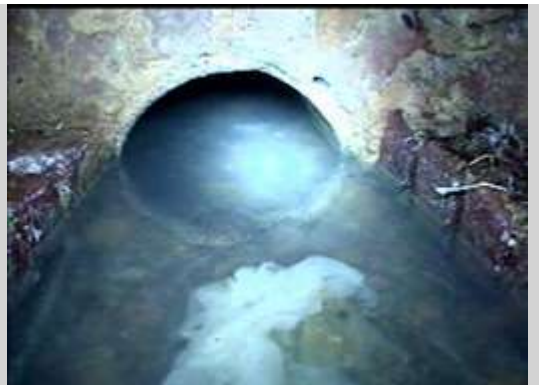
6 O'Clock Inflow

8 in. Circular Gravity Sewer
Pipe In @ 6 O'Clock

Pipe Height: (in.) Direct
Pipe Material: **Clay** ☐ Pipe Lined
Invert Depth: **9.25** (ft.) Flow Characteristics: **Slow**
Deposits: ☐ None ☐ Mud ☐ Sludge ☒ Debris ☐ Grease
Silt Depth: **1** (in.) Deposits Extent: **Medium**
Infiltration: **None** Pipe Seal Cond: **Sound**
